Study and Restoration of the Zeyrek Camii in Istanbul

Second Report, 2001–2005

ROBERT OUSTERHOUT | ZEYNEP AHUNBAY | METIN AHUNBAY

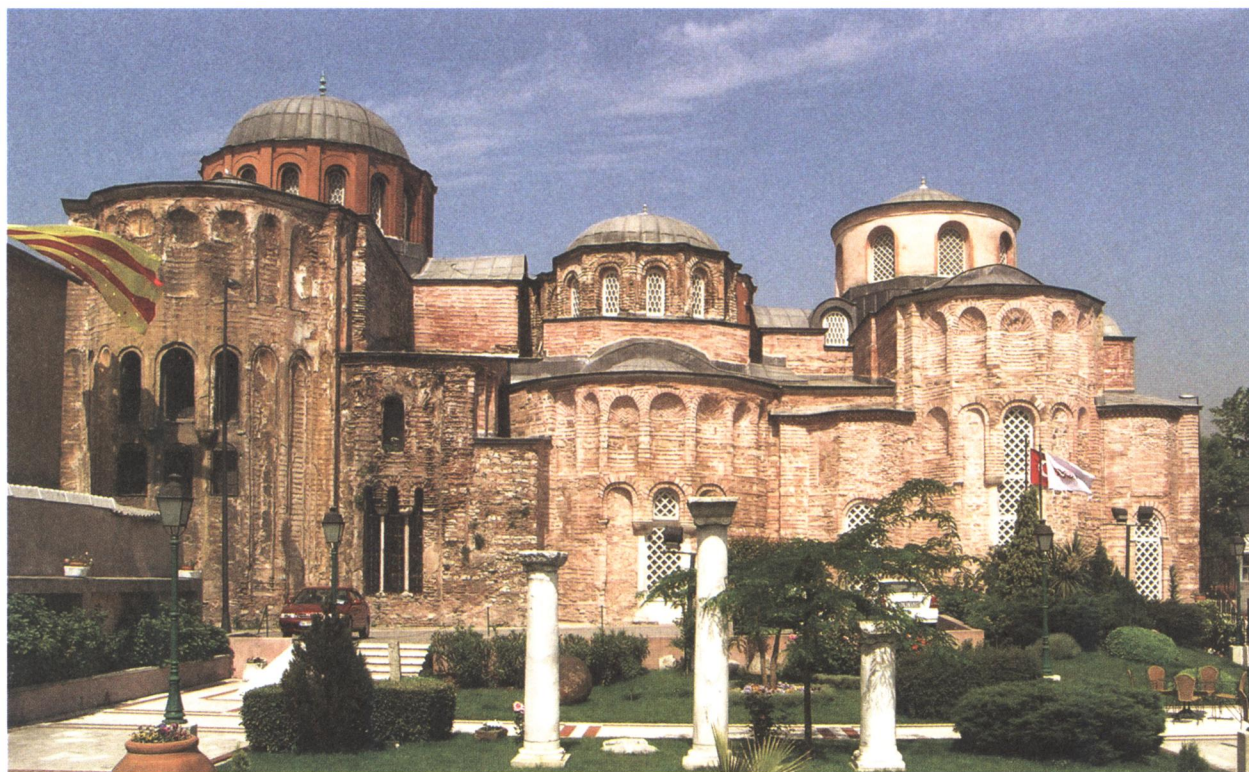
FIG. 1 Istanbul, Zeyrek Camii, general view from the east, following completion of program (June 2006)

In 2003, we completed the documentation of the entire east façade and adjacent surfaces of the complex (fig. 4). The stone-by-stone drawings were coded according to material and condition. Based on this information, we presented a detailed restoration proposal, and funding given through UNESCO allowed for the restoration of the east façades of the north and middle churches. Work in these areas began in 2004 and was completed in 2005 (figs. 1 and 5).

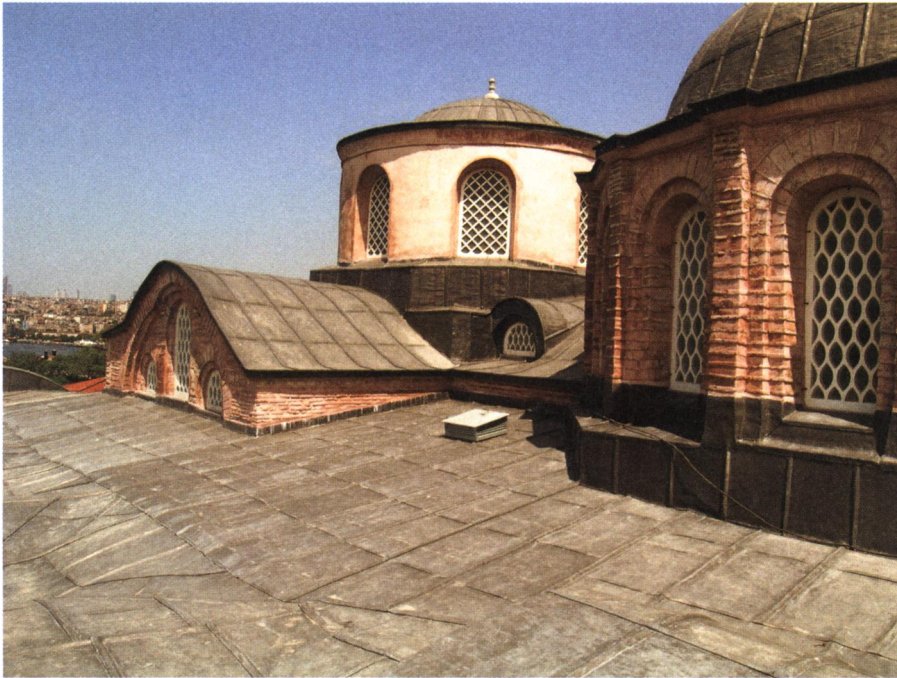
During 2002, we repaired the upper areas of the north church. The vault and windows of the west crossarm had been broken and repaired in the late Ottoman period, giving the façade arch a slightly pointed profile and raising the crown of the central window (fig. 6, left side). The restoration stabilized the masonry while leaving visible the evidence of historical changes. The north and south crossarm vaults were covered with lead sheeting in 2003.

FIG. 6 Zeyrek Camii, roof of the north gallery completed, looking northeast, with the western crossarm of the north church to the left (June 2004)

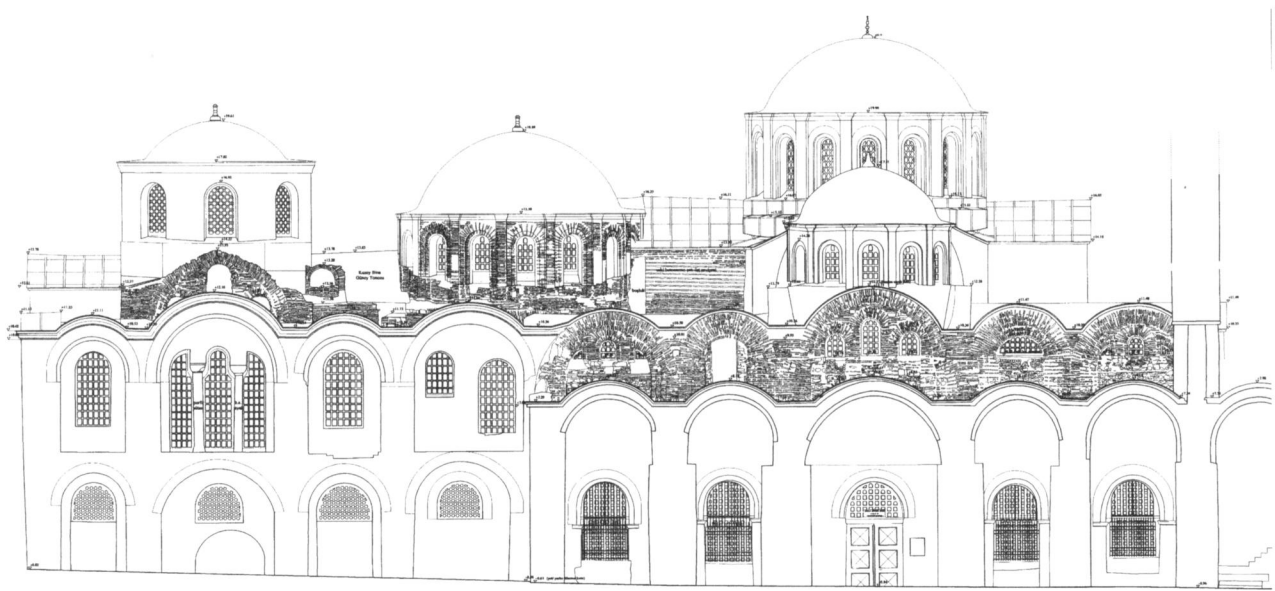
FIG. 10 Zeyrek Camii, measured drawing of the western façades (2005, Z. and M. Ahunbay)

The removal of the concrete roof from the exonarthex exposed large areas of the original west façade of the south gallery and thus gives us a better idea of the original window system of the building (fig. 10). In the lateral windows, for example, we exposed the traces of marble columns and capitals. The new roof is about a meter lower than the former concrete roof, corresponding to the original exonarthex roof level. The transformation of the central arcade for the construction of the gallery dome was also clarified (fig. 11).⁷

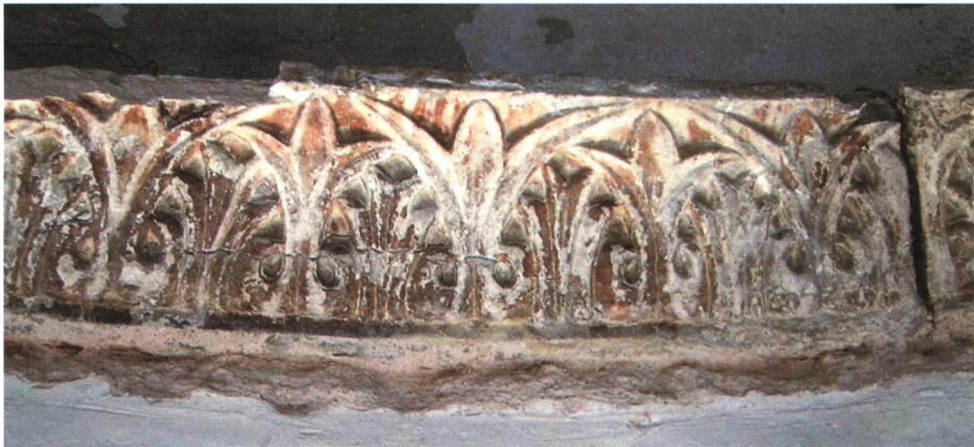
Cornices. Areas of red pigment, probably Armenian bole, are preserved on the interior marble cornices (figs. 15–16). Armenian bole was traditionally employed as a setting for gold leaf. Traces of gold leaf have been found on broken pieces of the upper cornice from the north church, including one now embedded in the window fill of the middle church. When the Ottoman plastering was removed from the marble cornice of the apse in the middle church in 2005, large areas of red pigment and gold leaf were exposed, although it often came away with the plaster. It would appear that all the interior cornices were covered with gold leaf.

FIG. 15 Zeyrek Camii, middle church, apse cornice showing traces of Armenian bole and gold leaf (August 2005)

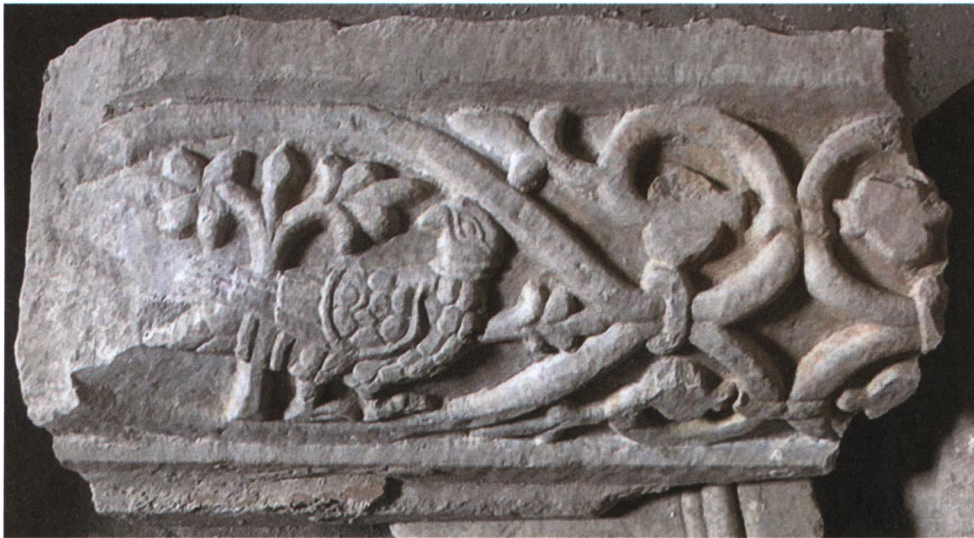
FIG. 16 Zeyrek Camii, fragment of the upper cornice from the north church with traces of Armenian bole in the field (July 2004)

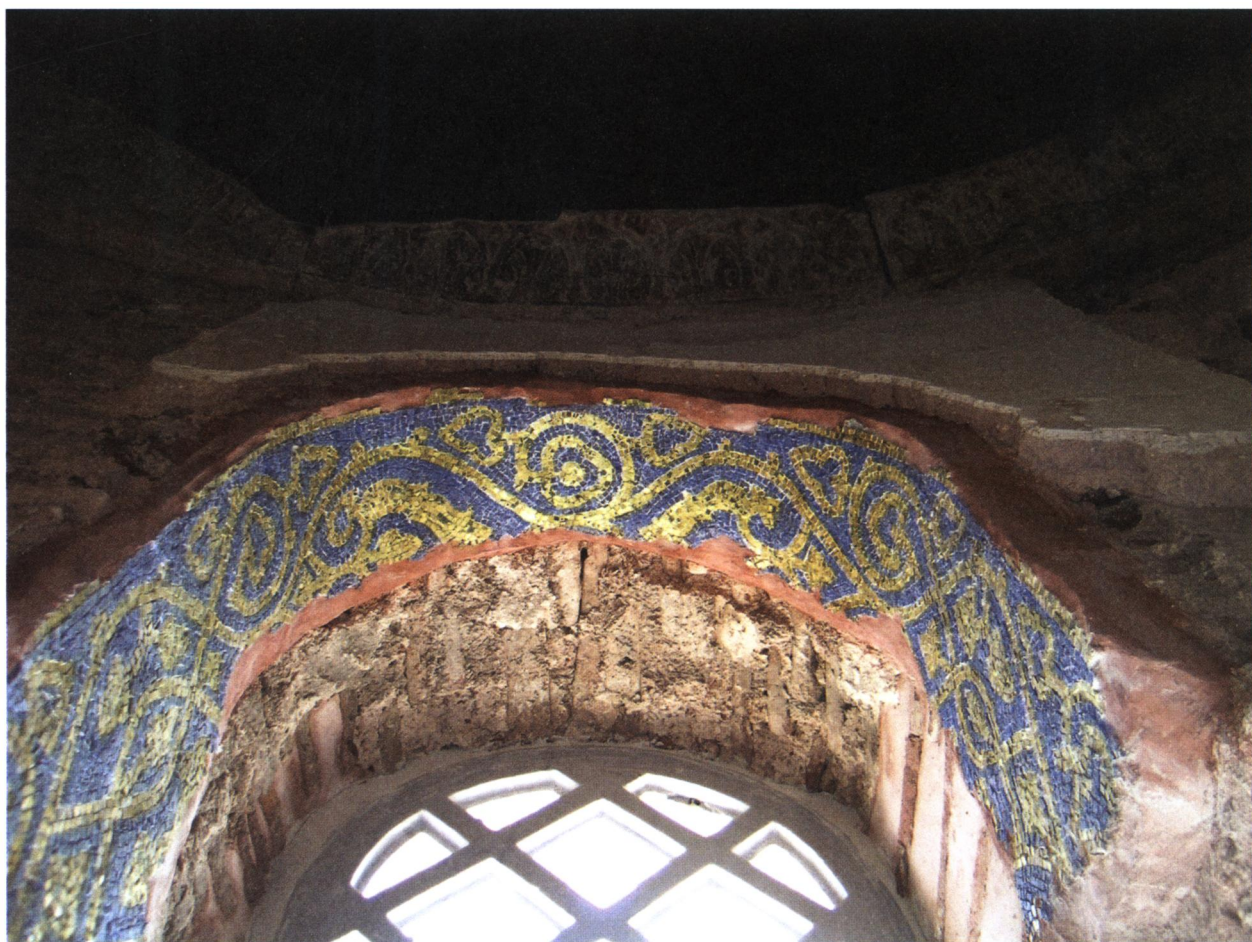
Mosaics. Three areas of in situ mosaic decoration were identified in 2005, in the reveals of the three apse windows of the middle church. The central light was opened, and the mosaic cleaned and stabilized by conservators from the Central Conservation Laboratory of the Ministry of Culture and Tourism (fig. 17). The pattern of the mosaic, a simple rinceau executed in gold on a dark blue background, is quite similar to the exposed mosaic pattern in the north window of the north church. Areas of mosaic survive in the lateral two arches of the middle church apse window as well, but these have not yet been uncovered. The area of mosaic in the central light is preserved to a maximum width of 43 cm of a total estimated width of 48 cm; it originally covered an area ca. 168 × 48 cm. The mosaic was set

FIG. 17 Zeyrek Camii, middle church, central light of apse window, mosaic after conservation (July 2005)

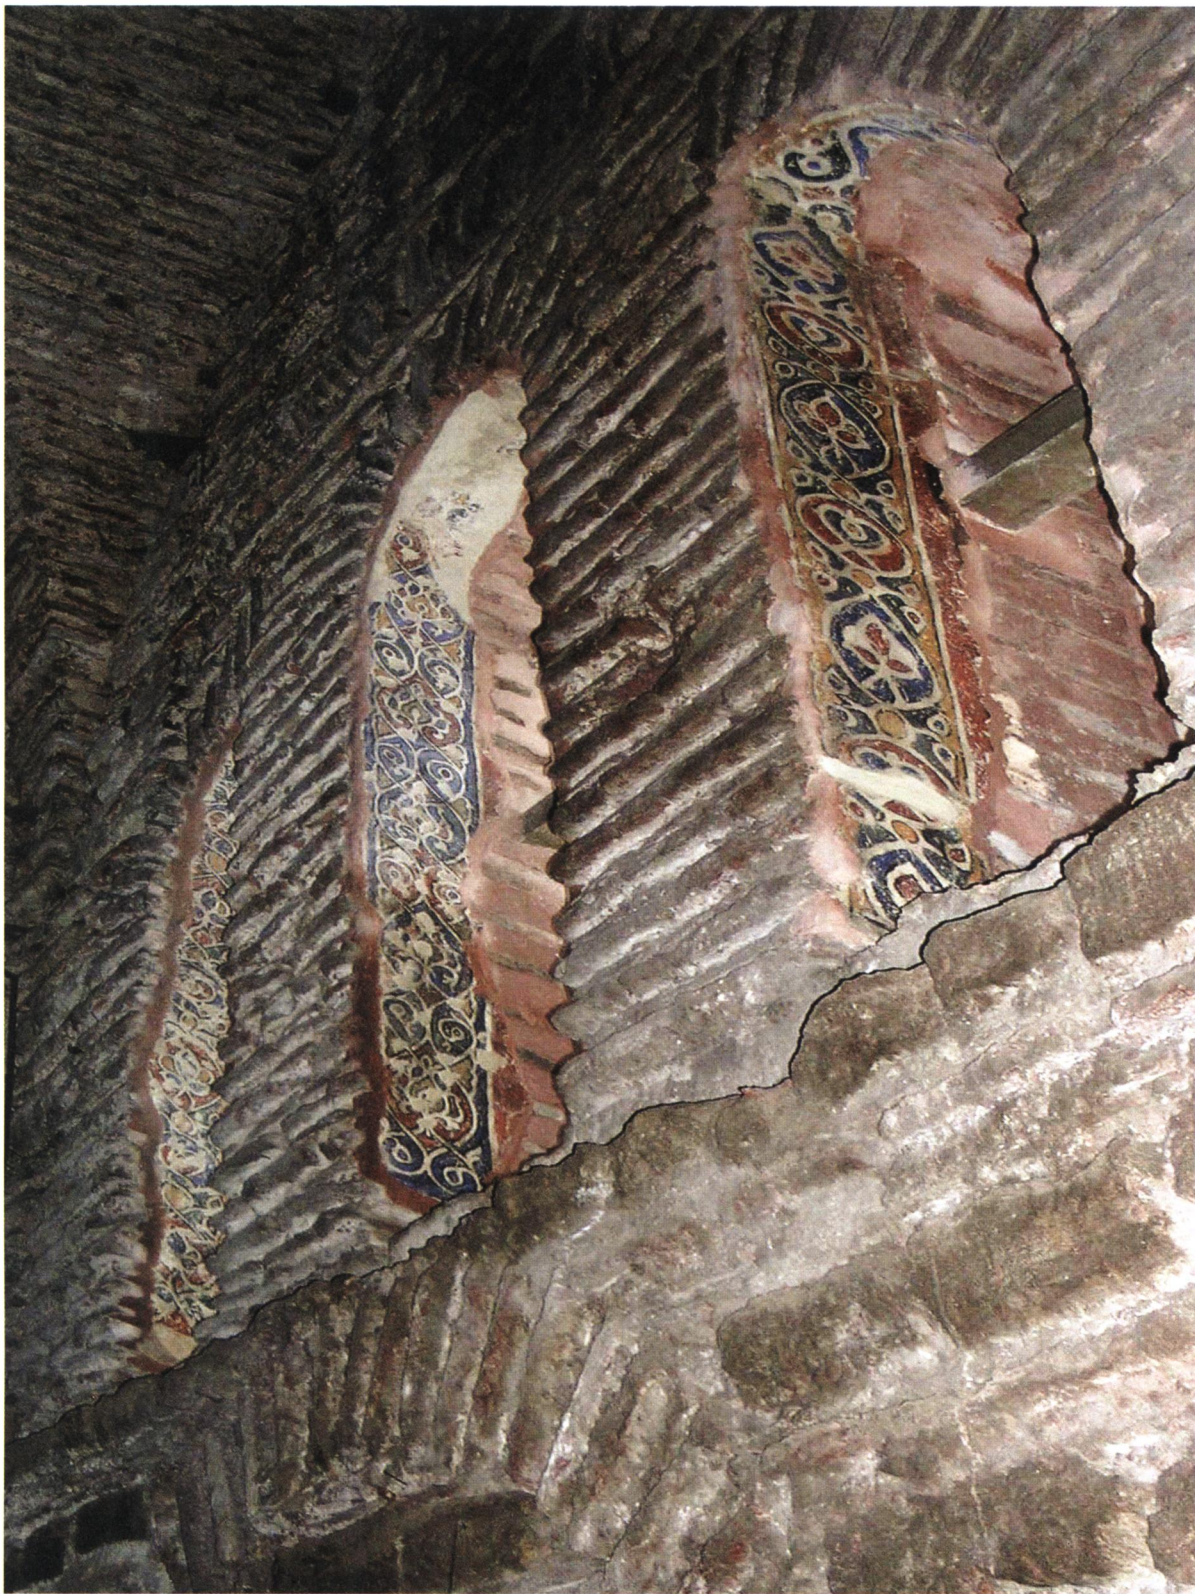
of 2005, the fresco decoration of the window reveals was exposed (fig. 18). The surfaces are patterned with rinceaux similar to those in the mosaics of the north and middle churches, but with more color and variety. The vine pattern has a white stem outlined in black, surrounding and enclosing fields of red, blue, and yellow.

FIG. 18 Zeyrek Camii, exonarthex, windows in north wall, frescoes in reveals, after conservation (May 2006)

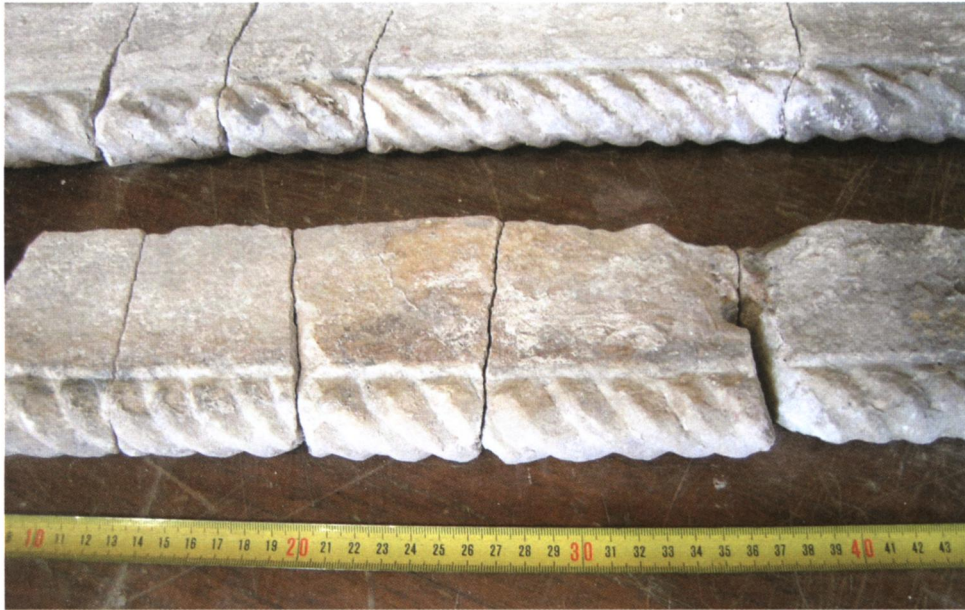
FIG. 20 Zeyrek Camii, torsade frames from marble revetments, found in the Ottoman fill of the middle church apse window (June 2005)

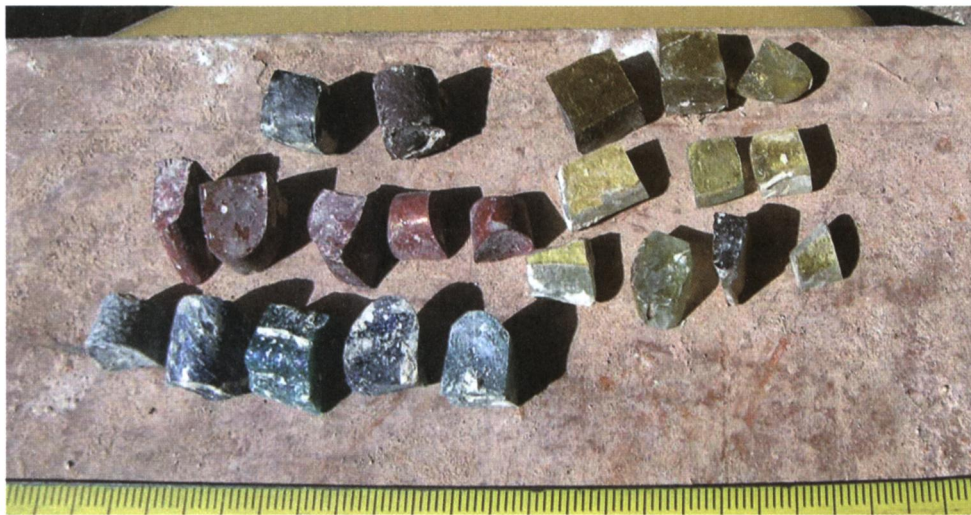
Mosaics. Most plentiful among the small finds are thousands of mosaic tesserae, which appear most commonly as material in the mortar from the eighteenth-century restoration (fig. 21). In the areas of rubble fill, we also found fragments of setting plaster, often with the tesserae still attached. We speculate that the

FIG. 21 Zeyrek Camii, mosaic tesserae found in the rubble fill of the Ottoman roof (August 2005)

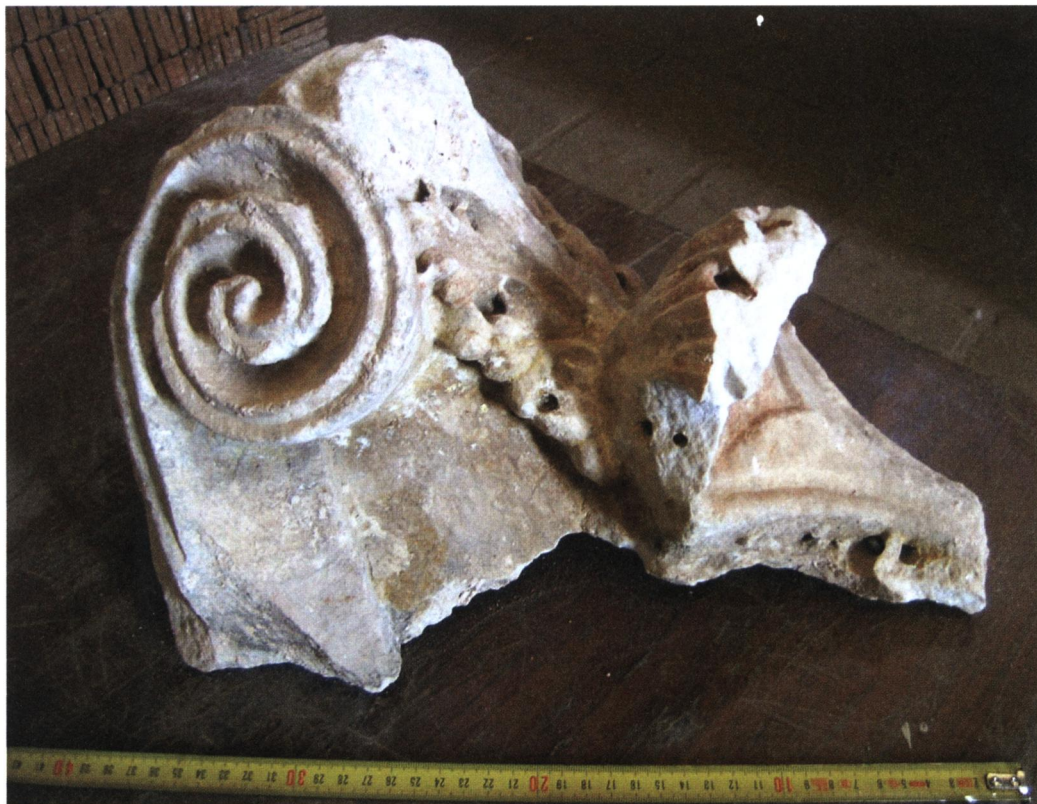
FIG. 22 Zeyrek Camii, fragment of a capital found in the rubble fill of the middle church apse window (June 2005)

detailed with drill holes (fig. 22). The piece measures 25.5×29.0 cm across its preserved upper surface by 37.0 cm tall. If complete it would have measured ca. 54 cm across at the abacus. Oddly, the preserved corner forms a 60-degree angle, and enough of it is preserved to conclude that this capital was originally three-sided and somewhat asymmetrical. From the carving, a fifth-century date may be proposed.

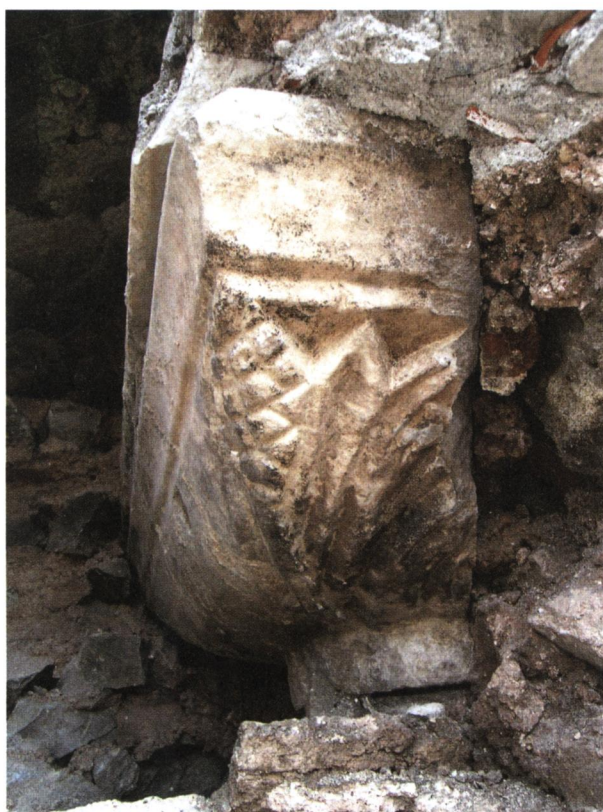
During the clearing of the north window in the gallery of the south church, a fragment of one of the capitals was discovered in situ, set with a sheet of lead to connect it to the column shaft beneath it (fig. 23). The capital has a fillet above a cavetto, with a setback to a second fillet, before the outer field, which is covered with a palmette pattern, with a pinecone-like bud at the corner. The lateral surface is undecorated. It measures ca. 32 cm high by 100 deep, with about 21 cm of its width preserved, from an estimated overall width of 76 cm. The column shaft below has a diameter of ca. 30 cm, so the capital flared dramatically above it. It seems

FIG. 23 Zeyrek Camii, fragment of capital still in situ, north window of the south church gallery (July 2004)
